Sealing technology in practical use:

Perfectly Sealed Closure

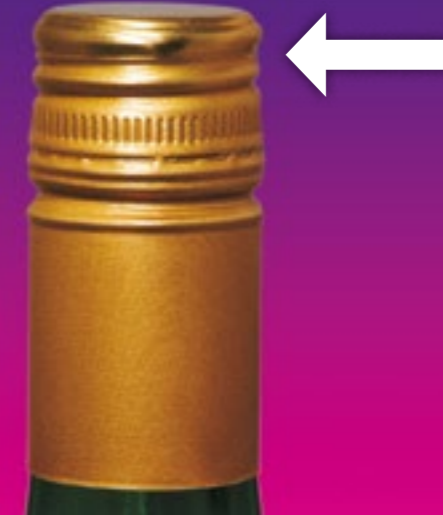
1. Failure

Insufficiently formed thread

- Closure cannot be opened
- Closure remains on the bottle
- Risk of leaking product
- Sealing disk/liner is not in the correct position

- Roller arms not set to gauge
- Side pressure too low (broken or incorrectly set side pressure spring, or – on pneumatic machines – side pressure gauge faulty or incorrectly set)
- Roller bushings badly worn
- Glass defect; bottle thread out of specification

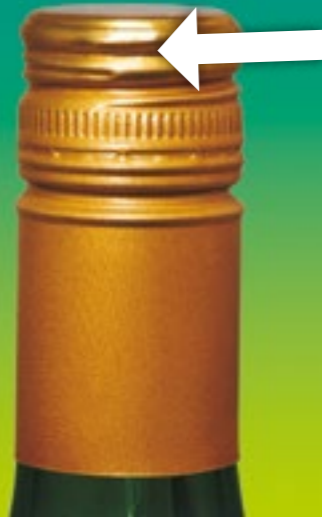
2. Failure

Shaped thread starts too deep

- Thread is deformed when closure is resealed by hand
- Insufficient hold for liner when the cap is opened, liner may remain on neck finish

- Roller arms not set to gauge. If cut is at start of thread, thread roller is set too high.
- Side pressure is too high (side pressure spring compressed excessively or – on pneumatic machines – gauge set too high)
- Thread roller is not free to move vertically or too roll
- Thread roller shaft is dirty, probably with particles of broken glass, which have penetrated the bushing
- Glass defect; bottle thread out of specification

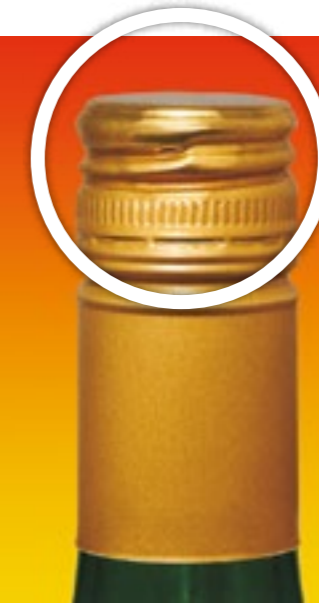
3. Failure

Split in formed thread

- Risk of injury when closure is opened by the customer
- Risk of leaking product if the slit becomes too long
- Visual fault

- Roller arms not set to gauge. If cut is at start of thread, thread roller is set too high
- Side pressure is too high (side pressure spring compressed excessively, or – on pneumatic machines – gauge set too high)
- Thread roller is not free to move vertically or to roll
- Thread roller shaft is dirty, probably with particles of broken glass, which have penetrated the bushing
- Glass defect; bottle thread out of specification

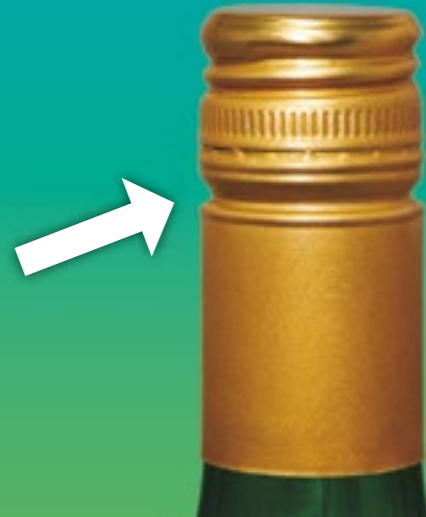
4. Failure

Tuck under shape too “weak”

- Spinning cap. Pilfer proof function will not operate
- Tuck under not formed correctly

- Height setup incorrectly on the upper part of the capping machine
- Position of the tuck under roller set too deep, the bushing may not be secured
- Neck finish height on the bottle is on minimum or below
- Angle under the tucking bead is too large or steep

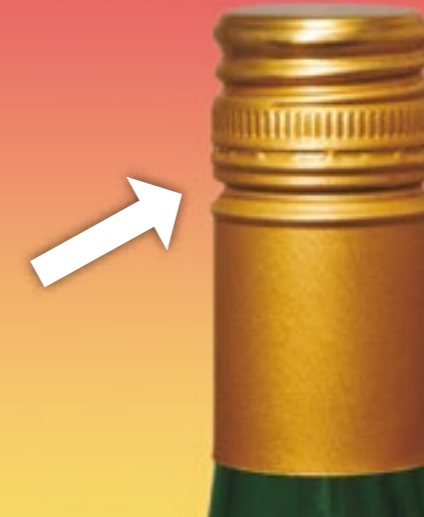
5. Failure

Tuck under shape too “sharp”

- Spinning Cap. Pilfer proof function will not operate
- Sharp tuck under groove is at a very high position

- Setup of upper part of capping machine too high
- Position of tuck under roller set too high
- Neck finish height on the bottle is on tolerance maximum or above
- Reform block is loose

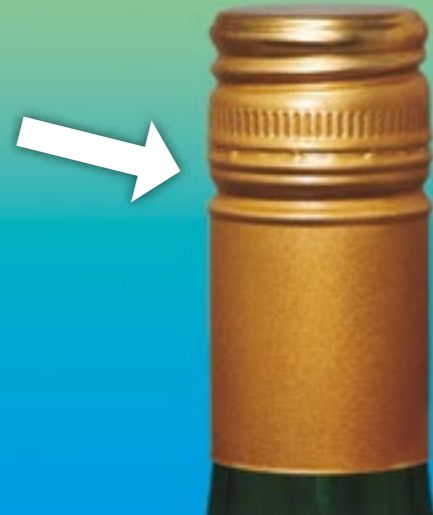
6. Failure

Tuck under not formed sufficiently

- Spinning Cap
- Pilfer proof function will not operate

- Insufficient lateral pressure on tuck under rollers
- Lateral pressure spring of tuck under roller is worn or broken
- Operating and / or tuck under roller lever is jammed (remove, clean, lubricate)
- Zero-positions of tuck under roller incorrect (gap between rollers too large)
- Where there are two tuck under rollers, diameter difference between nose radius and step too small
- Bottle neck diameter directly below the neck finish is too large

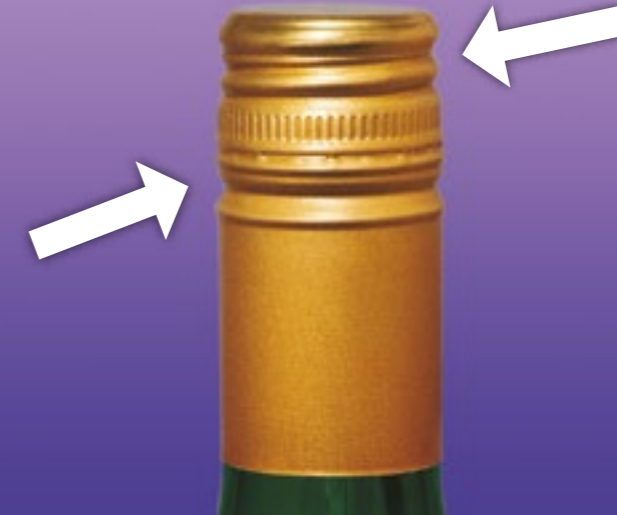
7. Failure

Insufficiently shaped thread and tuck under

- Closure cannot be opened
- Spinning cap. Pilfer proof function will not operate
- Thread is easily over-torqued when closure is resealed by hand
- Risk of leaking product, sealing disk is not held in the proper position

- Height of upper part of capping machine set too high (very typical mistake)
- Bottle footprint plate is loose
- Height of bottle is out of specification
- Head load spring is set incorrectly, worn or broken

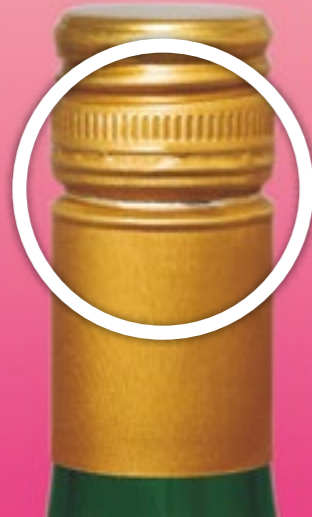
8. Failure

Tuck under damage

- Closure breaks not at the perforation, but at the tuck under area
- Risk of injury when closure is opened by customer
- Visual mechanical fault

- Lateral pressure of tuck under rollers set too high
- Operating and/or tuck under roller lever clamps jammed
- Tuck under roller nose radius is worn or damaged
- Zero-position of tuck under roller is set incorrectly (gap between roller is too small)
- Head speed set too high
- Bottle neck diameter directly below the neck finish is too large, out of specification

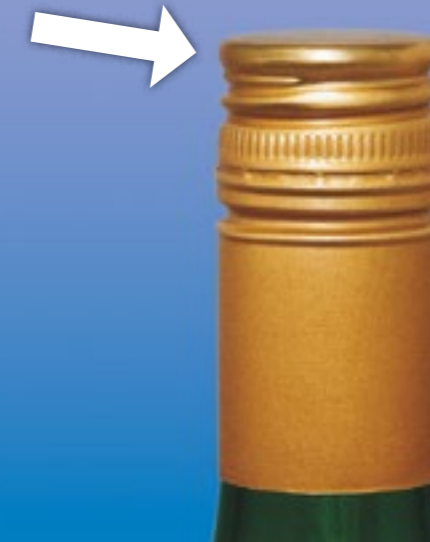
9. Failure

Too little or no reform depth

- Risk of leaking product
- High oxygen transmission rate possible,
- Wine could oxidize at a faster rate

- Upper part of sealing machine is set too high
- Head load set low (spring wrong, worn or broken)
- Reform block spring is broken and impedes the moveable reform block disk
- Neck finish core diameter is above the maximum of tolerance
- Height of bottle is below the minimum specification

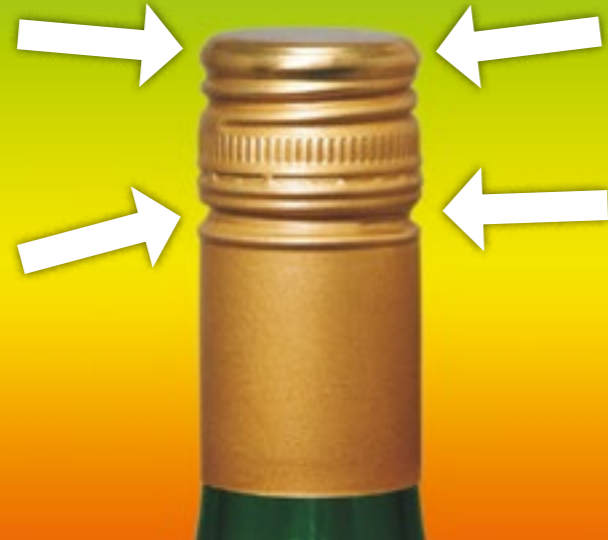
10. Failure

Closure not symmetrically shaped, sloping reform and tuck under

- Not all perforations open, closure remains on bottle
- Spinning Cap, pilfer proof function not operational
- Risk of leaking product due to irregular sealing disk compression
- High oxygen transmission rate possible,
- Wine could oxidize faster than expected

- Incorrect or worn central star
- Central star is not aligned with axis of sealing head
- Outside bottle guide too far away from bottle
- Bottle footprint plate of capping machine is worn

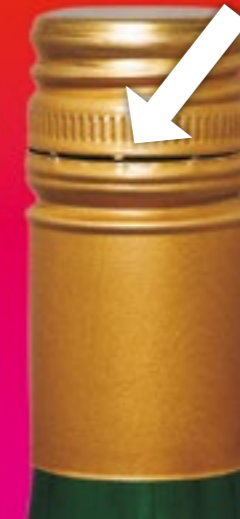
11. Failure

Perforation breaks during sealing

- Pilfer proof function does not work reliable when too many bridges are broken
- Visual mechanical fault

- Lateral pressure or tuck under roller pressure set too high
- Position of tuck under rollers is too high
- High level of ovality on neck finish tucking bead
- Neck diameter at cap skirt positions is too small and / or high ovality
- Diameter of neck finish tucking bead too small
- Radius on the tucking bead is too large
- Possibility that the bridges of the closure are too narrow
