Perfectly Sealed Closure:

www.viscoseclosures.com

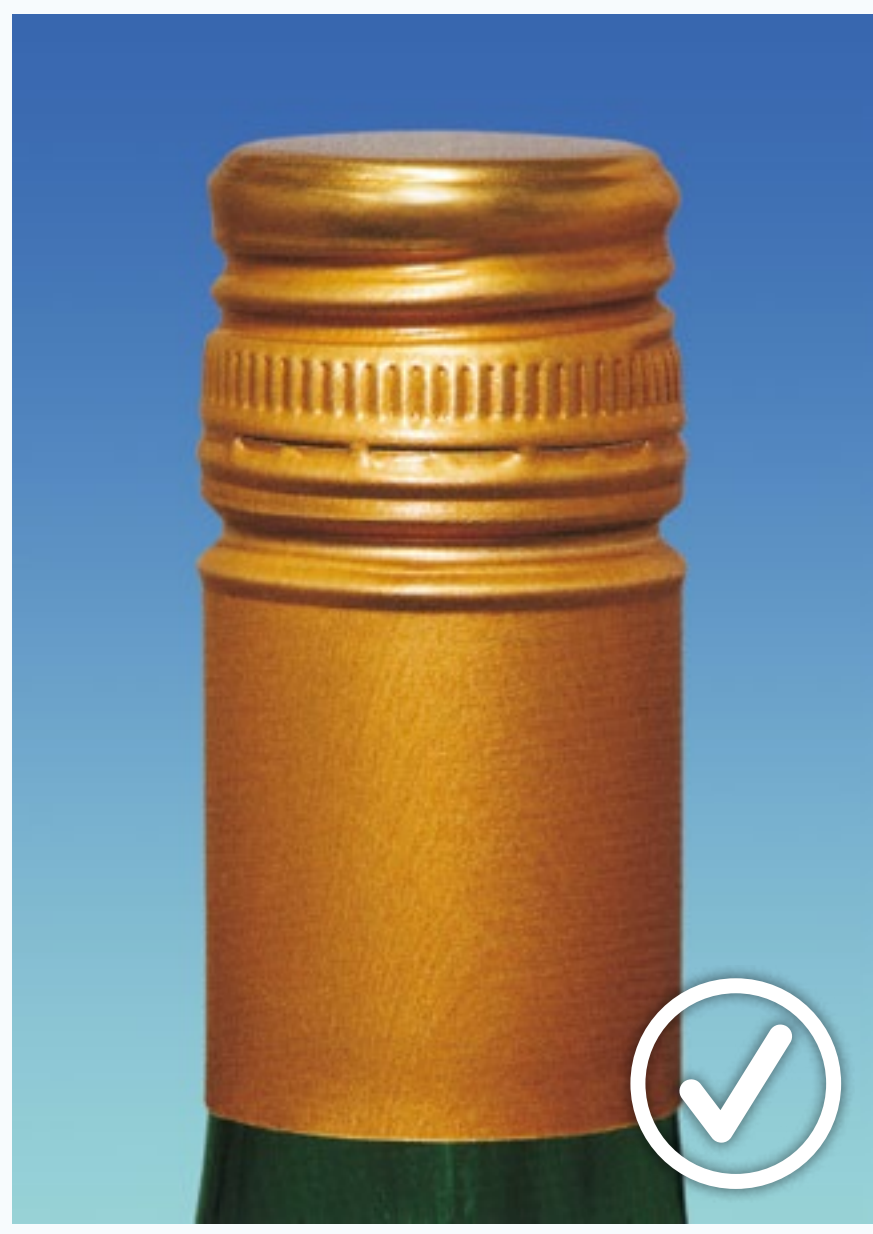
Appearance of the closure:

- Symmetrical and well shaped reform
- Damage free thread start
- Correctly formed thread with sufficient forming depth
- Faultless perforation
- Precise and cleanly made tuck-under

Results:

- Reliable long-term seal
- Closure opens well with correct pilfer proof function
- Closure will reseal smoothly and safely

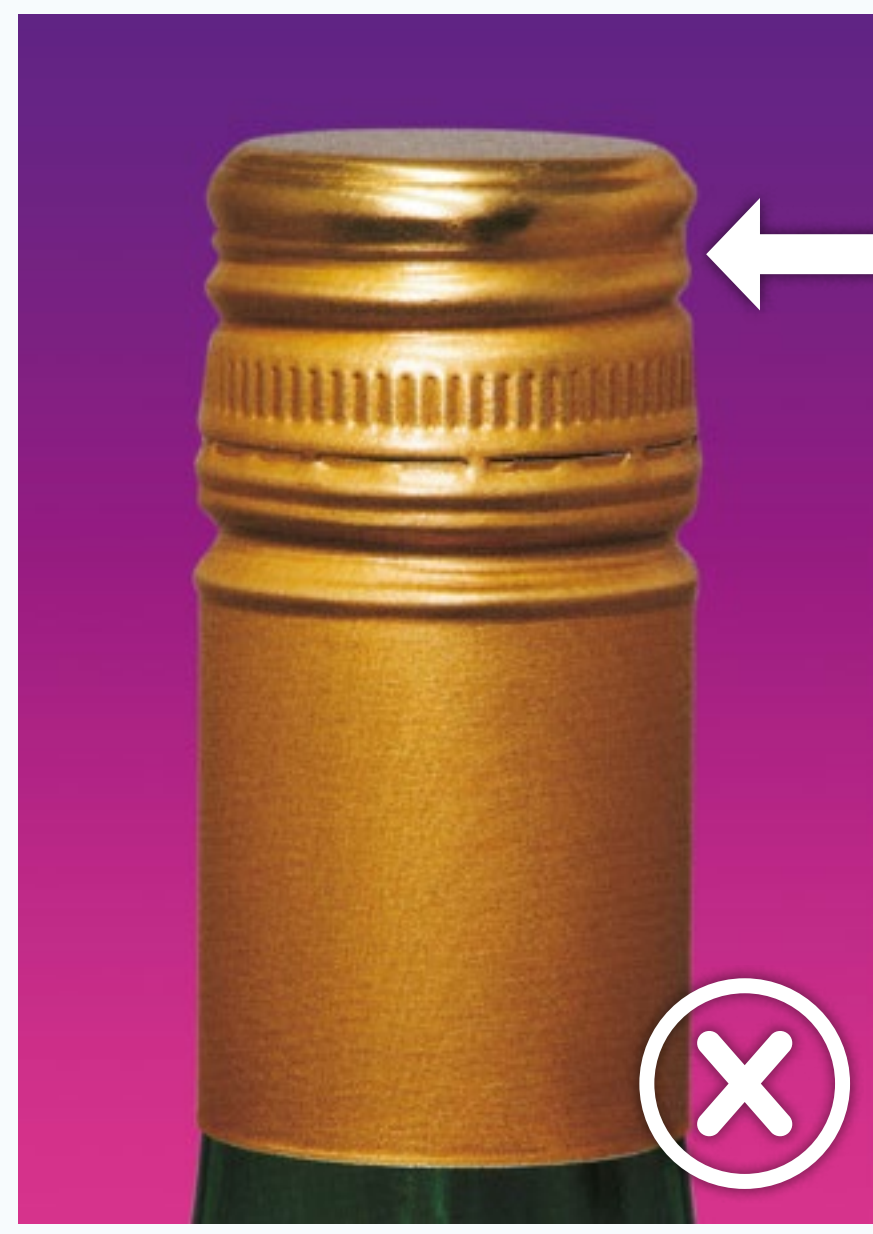
1. Failure Insufficiently formed thread

Effect:

- Closure cannot be opened
- Closure remains on the bottle
- Risk of leaking product
- Sealing disk/liner is not in the correct position

Possible Causes:

- Roller arms not set to gauge
- Side pressure too low (broken or incorrectly set side pressure spring, or – on pneumatic machines – side pressure gauge faulty or incorrectly set)
- Roller bushings badly worn
- Glass defect; bottle thread out of specification

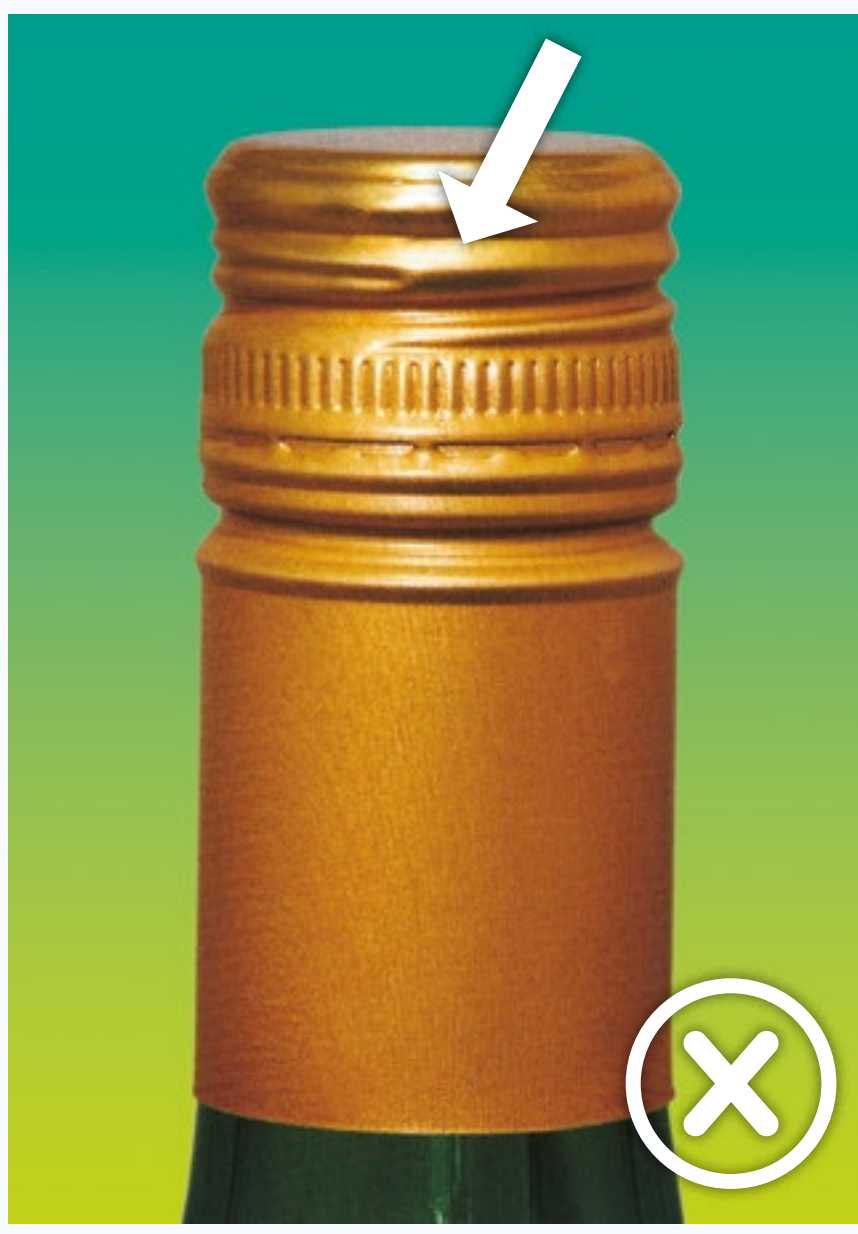
2. Failure Shaped thread starts too deep

Effect:

- Thread is deformed when closure is resealed by hand
- Insufficient hold for liner when the cap is opened, liner may remain on neck finish

Possible Causes:

- Roller arms not set to gauge. If cut is at start of thread, thread roller is set too high.
- Side pressure is too high (side pressure spring compressed excessively, or – on pneumatic machines – gauge set too high)
- Thread roller is not free to move vertically or too roll
- Thread roller shaft is dirty, probably with particles of broken glass, which have penetrated the bushing
- Glass defect; bottle thread out of specification

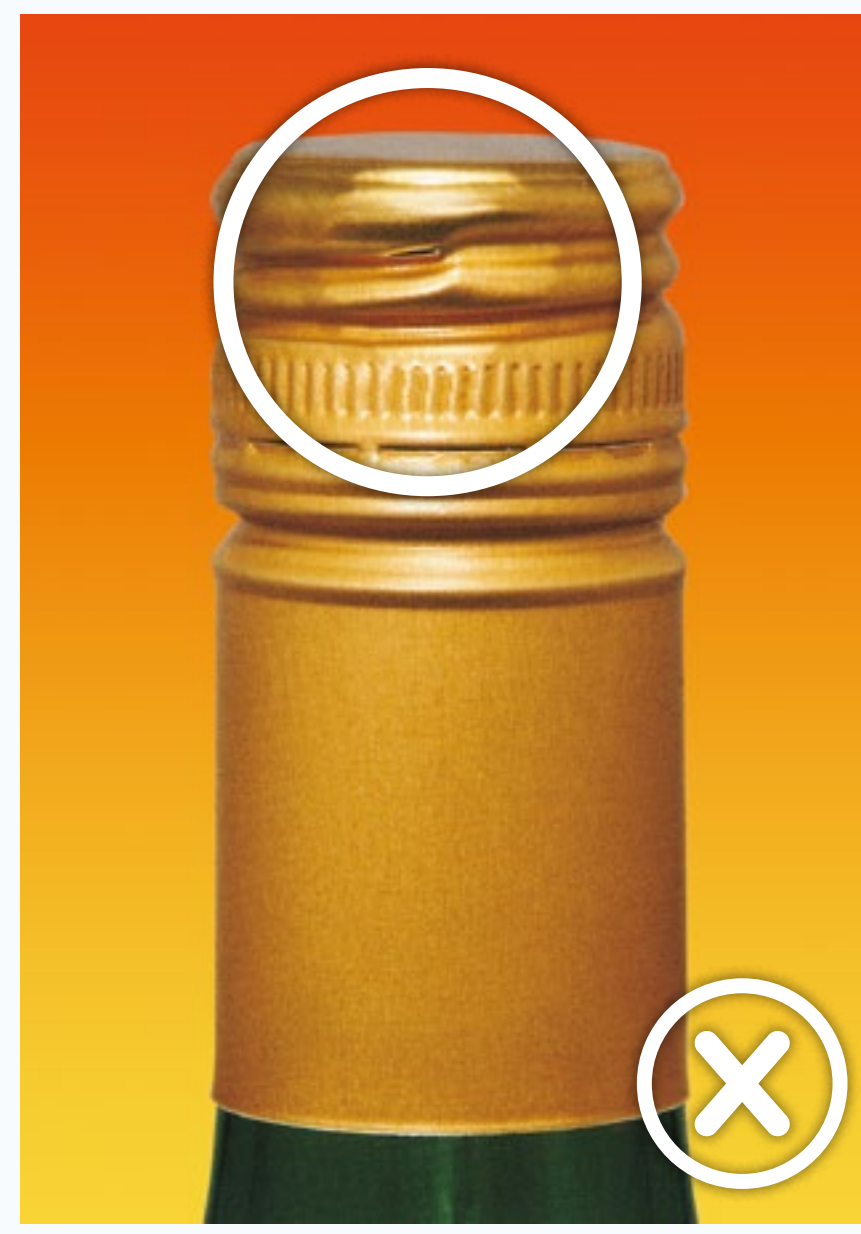
3. Failure Split in formed thread

Effect:

- Risk of injury when closure is opened by the customer
- Risk of leaking product if the slit becomes too long
- Visual fault

Possible Causes:

- Roller arms not set to gauge. If cut is at start of thread, thread roller is set too high
- Side pressure is too high (side pressure spring compressed excessively, or – on pneumatic machines – gauge set too high)
- Thread roller is not free to move vertically or to roll
- Thread roller shaft is dirty, probably with particles of broken glass, which have penetrated the bushing
- Glass defect; bottle thread out of specification

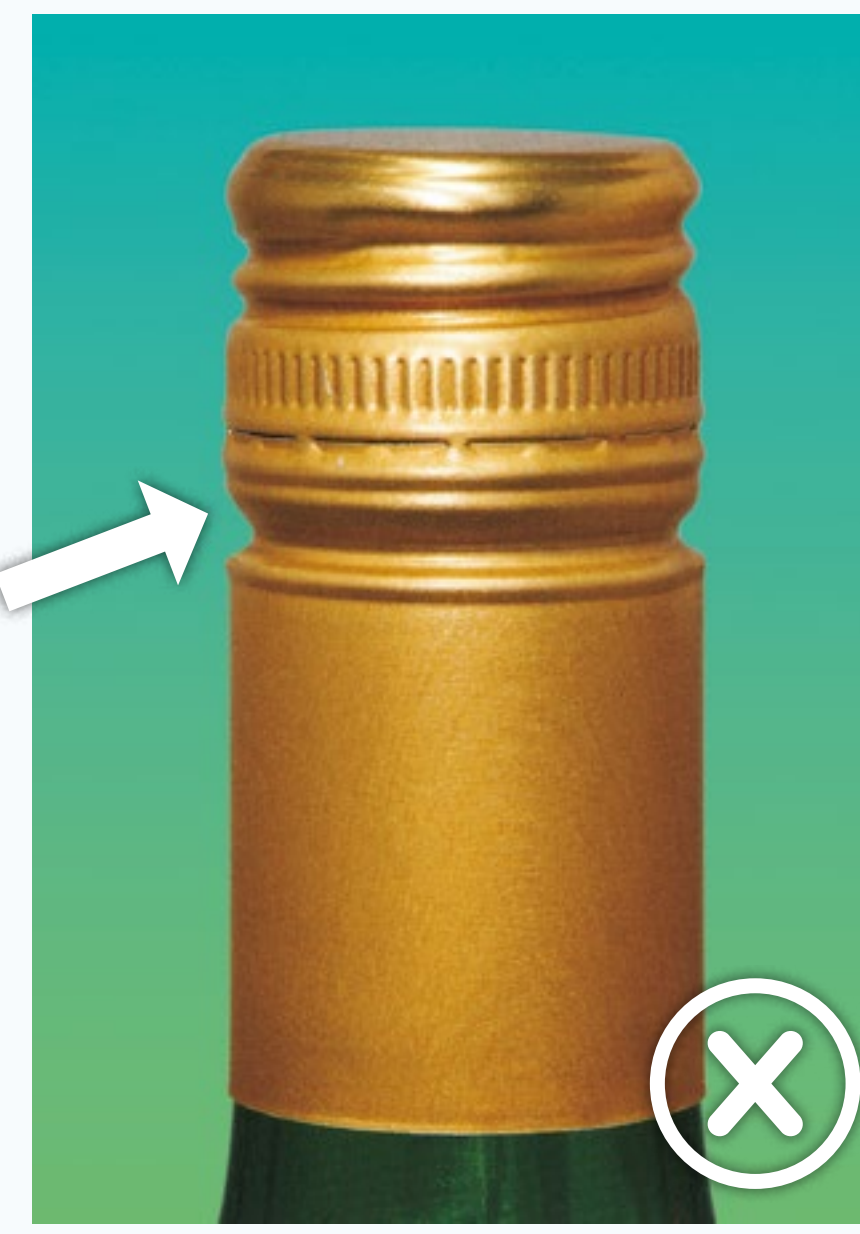
4. Failure Tuck under shape too "weak"

Effect:

- Spinning cap. Pilfer proof function will not operate
- Tuck under not formed correctly

Possible Causes:

- Height setup incorrectly on the upper part of the capping machine
- Position of the tuck under roller set too deep, the bushing may not be secured
- Neck finish height on the bottle is on minimum or below
- Angle under the tucking bead is too large or steep

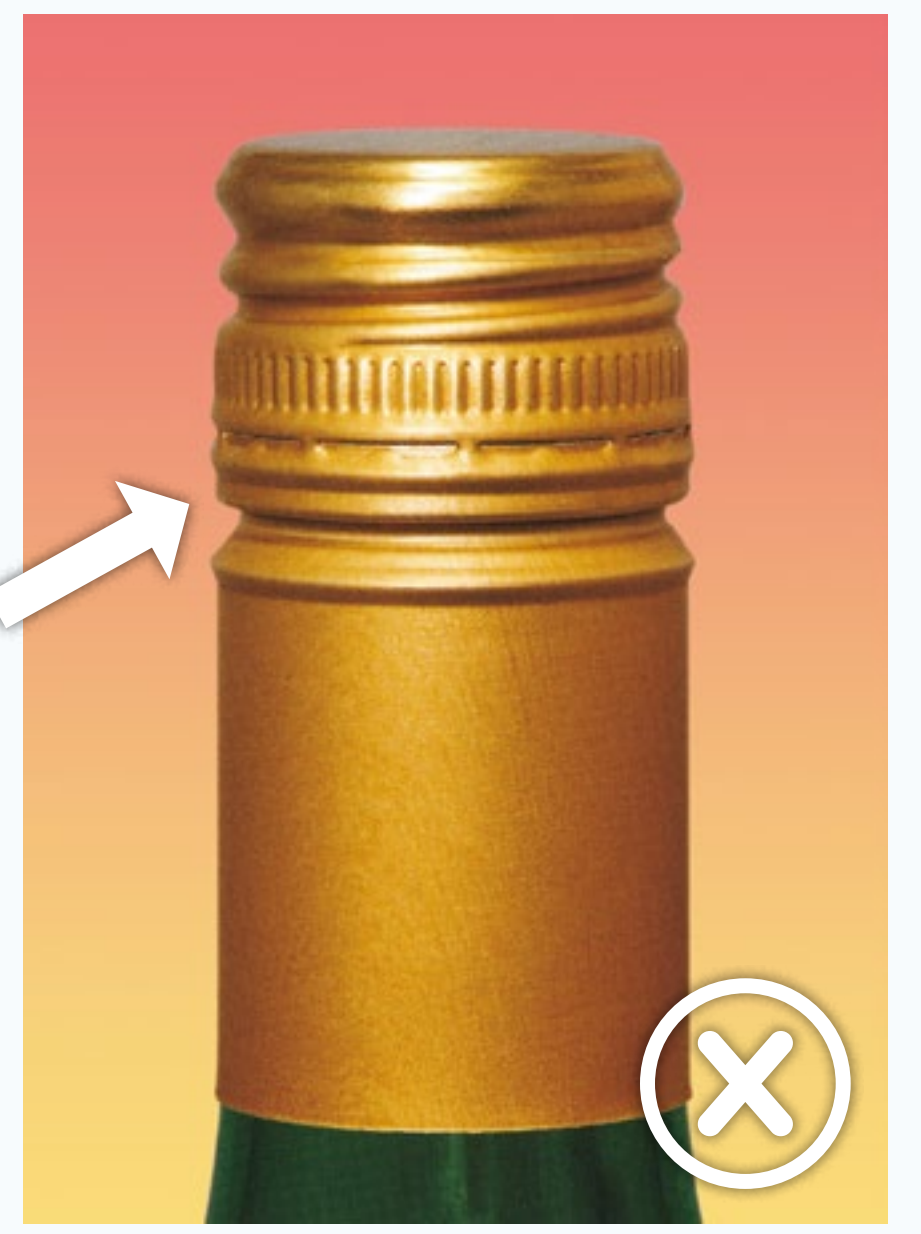
5. Failure Tuck under shape too "sharp"

Effect:

- Spinning Cap. Pilfer proof function will not operate
- Sharp tuck under groove is at a very high position

Possible Causes:

- Setup of upper part of capping machine too high
- Position of tuck under roller set too high
- Neck finish height on the bottle is on tolerance maximum or above
- Reform block is loose

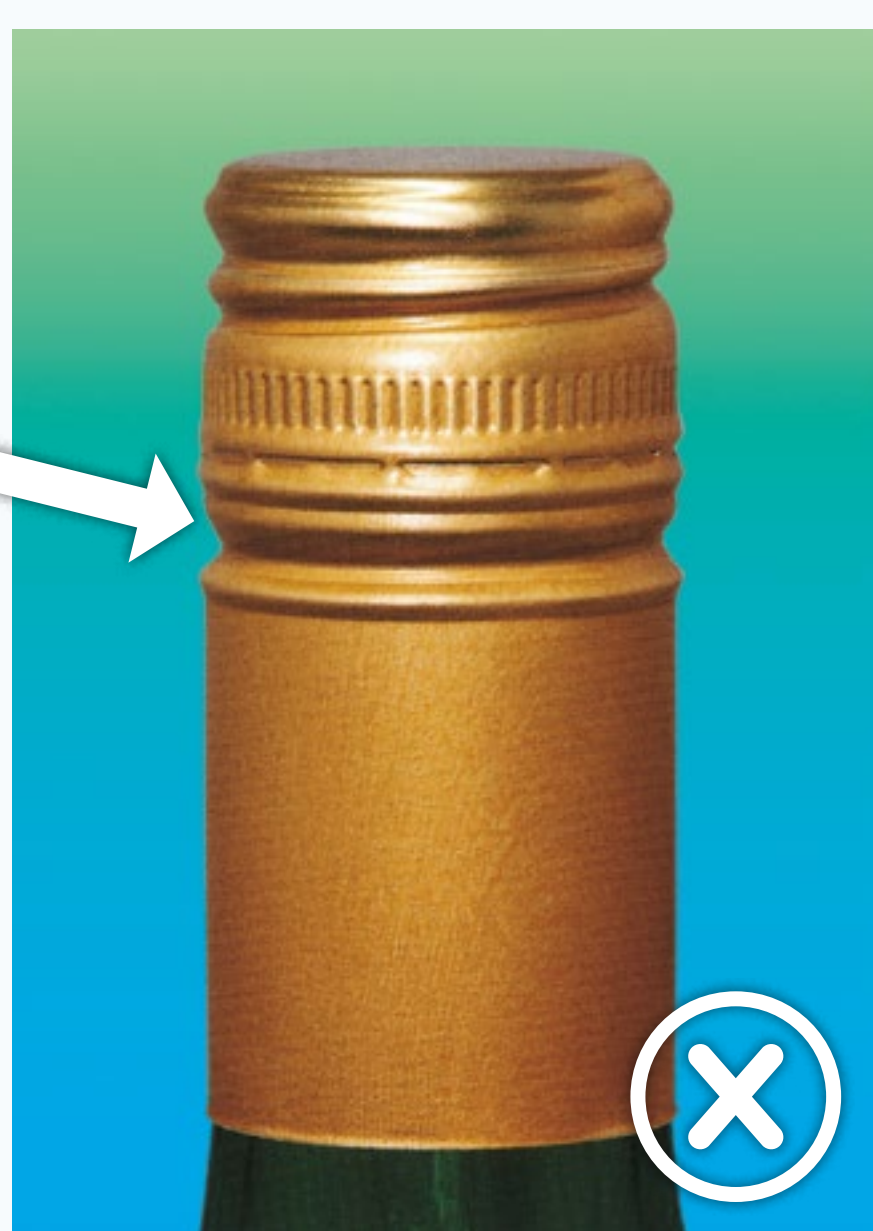
6. Failure Tuck under not formed sufficiently

Effect:

- Spinning Cap
- Pilfer proof function will not operate

Possible Causes:

- Insufficient lateral pressure on tuck under rollers
- Lateral pressure spring of tuck under roller is worn or broken
- Operating and / or tuck under roller lever is jammed (remove, clean, lubricate)
- Zero-positions of tuck under roller incorrect (gap between rollers too large)
- Zero-positions of tuck under roller incorrect (gap between rollers too large)
- Where there are two tuck under rollers, diameter difference between nose radius and step too small
- Bottle neck diameter directly below the neck finish is too large

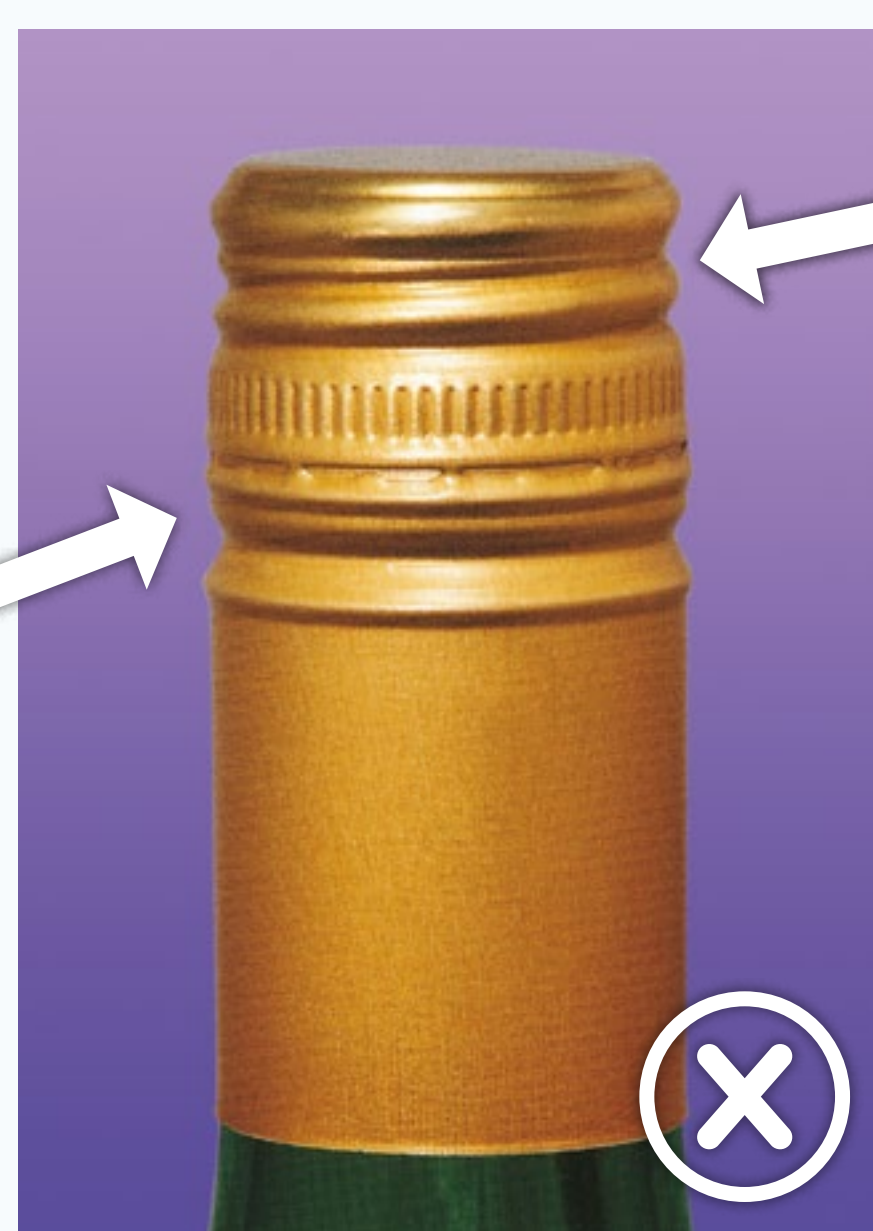
7. Failure Insufficiently shaped thread and tuck under

Effect:

- Closure cannot be opened
- Spinning cap. Pilfer proof function will not operate
- Thread is easily over-torqued when closure is resealed by hand
- Risk of leaking product, sealing disk is not held in the proper position

Possible Causes:

- Height of upper part of capping machine set too high (very typical mistake)
- Bottle footprint plate is loose
- Height of bottle is out of specification
- Head load spring is set incorrectly, worn or broken

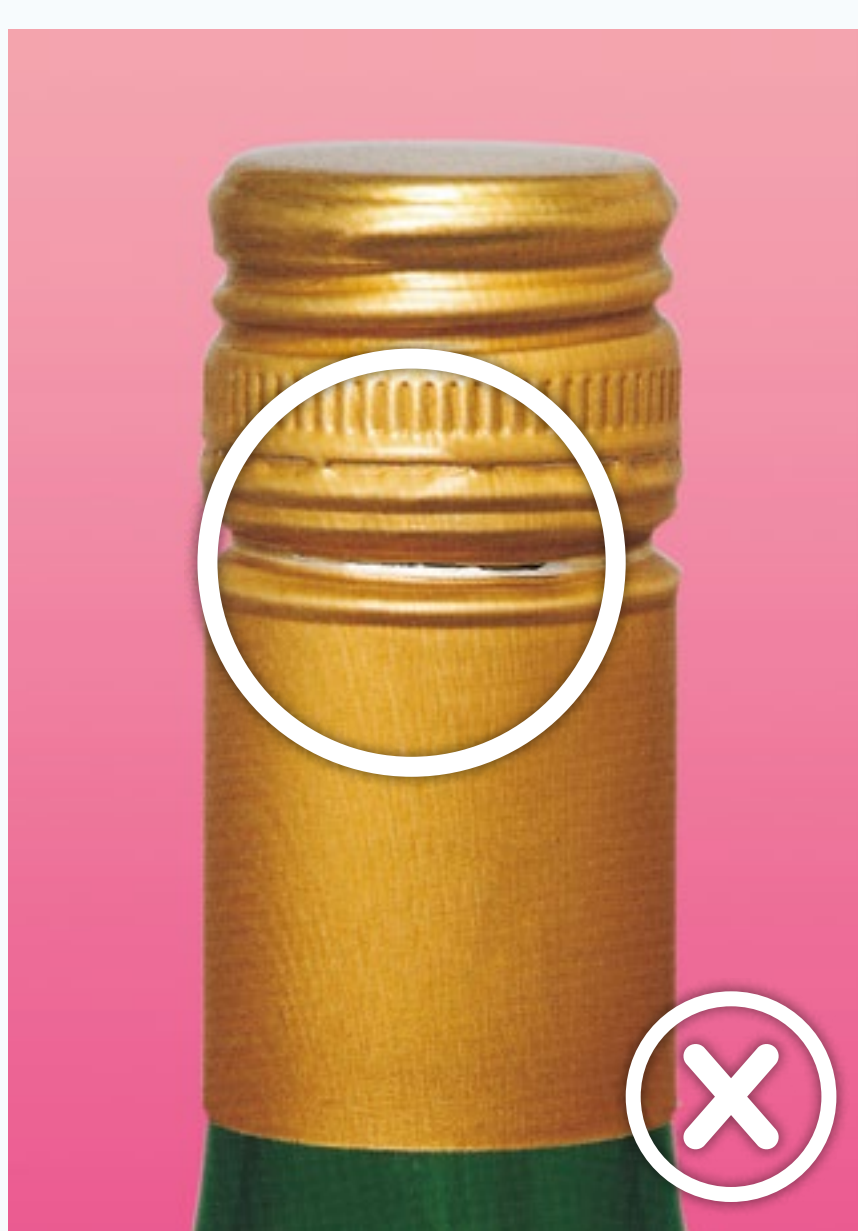
8. Failure Tuck under damage and tuck under

Effect:

- Closure breaks not at the perforation, but at the tuck under area
- Risk of injury when closure is opened by customer
- Visual mechanical fault

Possible Causes:

- Lateral pressure of tuck under rollers set too high
- Operating and/or tuck under roller lever clamps jammed
- Tuck under roller nose radius is worn or damaged
- Zero-position of tuck under roller is set incorrectly (gap between roller is too small)
- Head speed set too high
- Bottle neck diameter directly below the neck finish is too large, out of specification

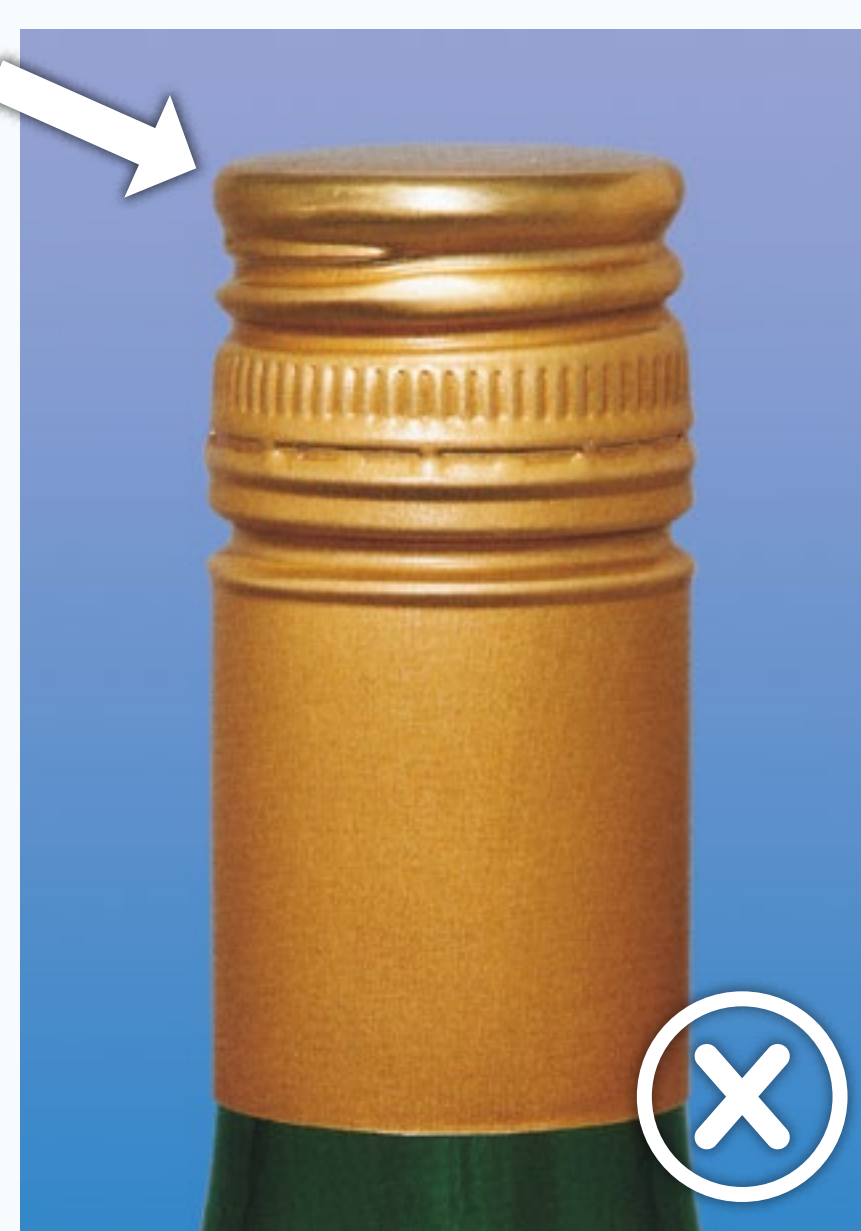
9. Failure Too little or no reform depth

Effect:

- Risk of leaking product
- High oxygen transmission rate possible
- Wine could oxidize at a faster rate

Possible Causes:

- Upper part of sealing machine is set too high
- Head load set low (spring wrong, worn or broken)
- Reform block spring is broken and impedes the moveable reform block disk
- Neck finish core diameter is above the maximum of tolerance
- Height of bottle is below the minimum specification

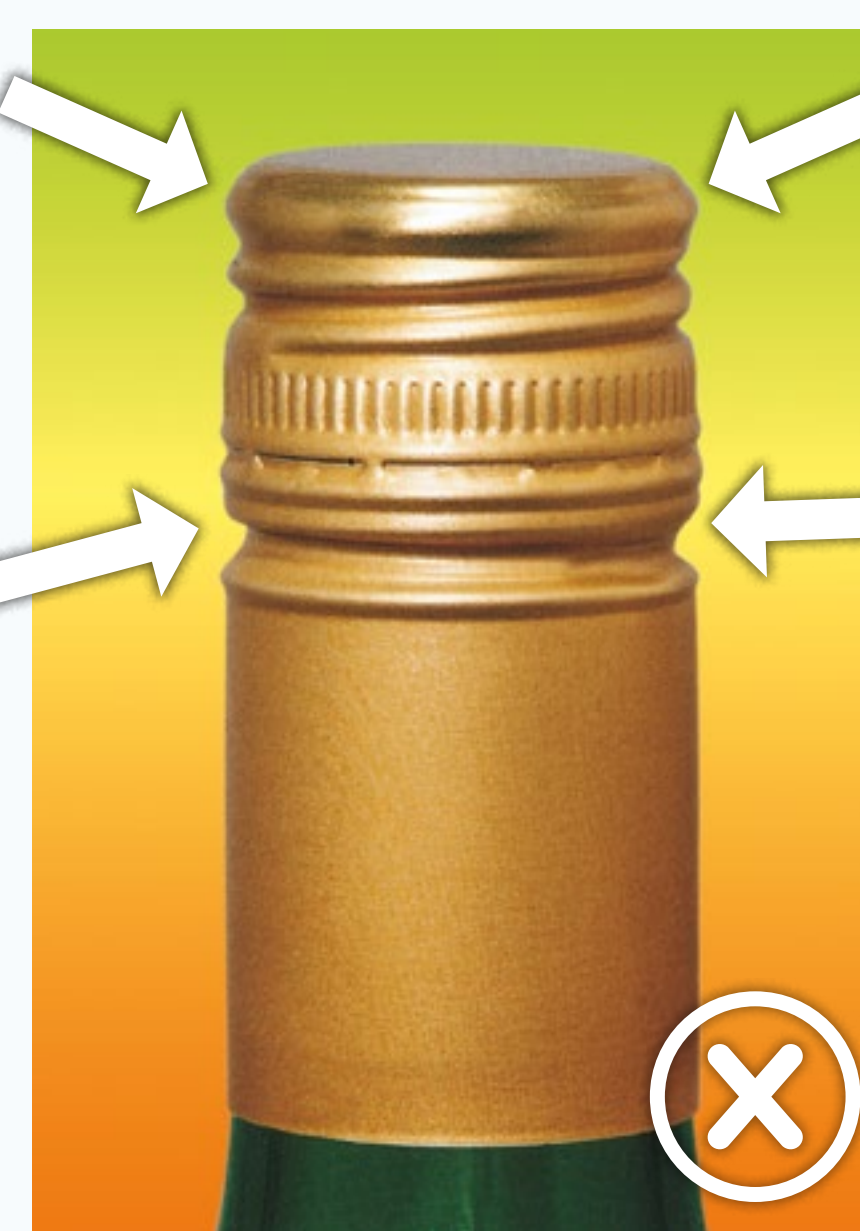
10. Failure Closure not symmetrically shaped, sloping reform and tuck under

Effect:

- Not all perforations open, closure remains on bottle
- Spinning Cap, pilfer proof function not operational
- Risk of leaking product due to irregular sealing disk compression
- High oxygen transmission rate possible
- Wine could oxidize faster than expected

Possible Causes:

- Incorrect or worn central star
- Central star is not aligned with axis of sealing head
- Outside bottle guide too far away from bottle
- Bottle footprint plate of capping machine is worn

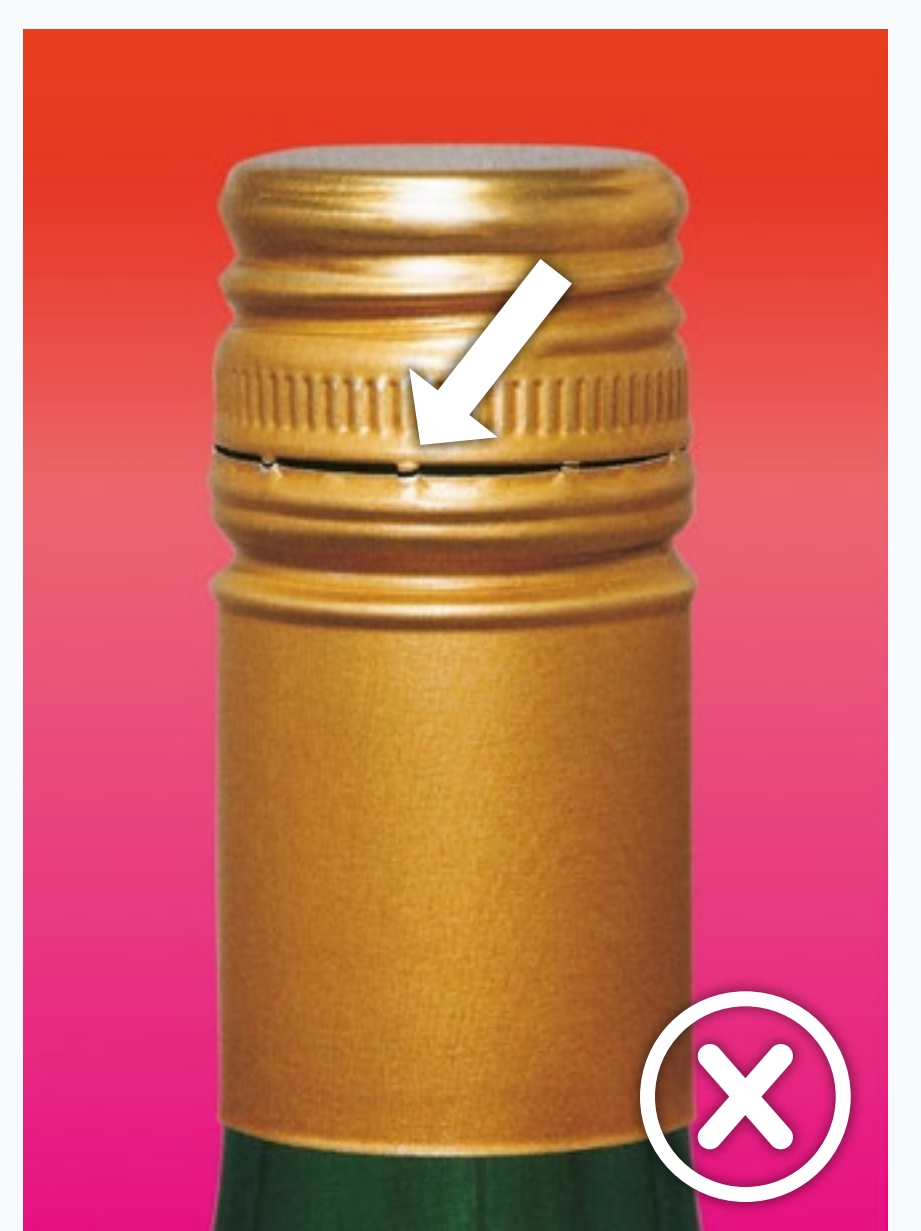
11. Failure Perforation breaks during sealing

Effect:

- Pilfer proof function does not work reliable when too many bridges are broken
- Visual mechanical fault

Possible Causes:

- Lateral pressure or tuck under roller pressure set too high
- Position of tuck under rollers is too high
- High level of ovality on neck finish tucking bead
- Neck diameter at cap skirt positions is too small and / or high ovality
- Diameter of neck finish tucking bead too small
- Radius on the tucking bead is too large
- Possibility that the bridges of the closure are too narrow

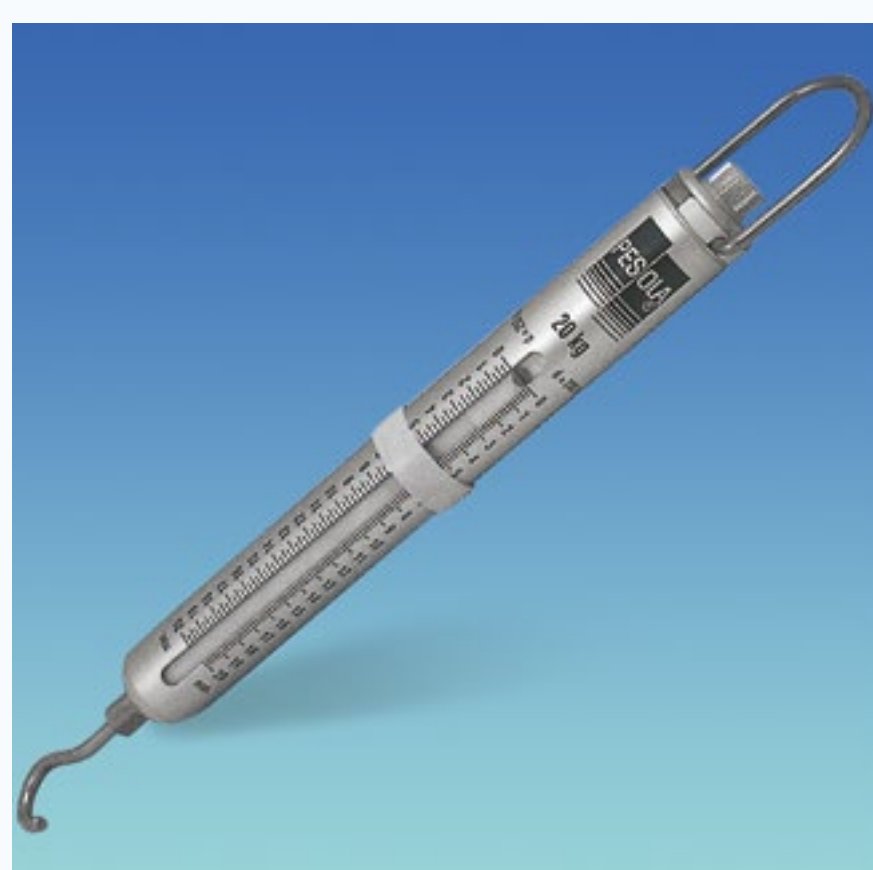
Spring Scale

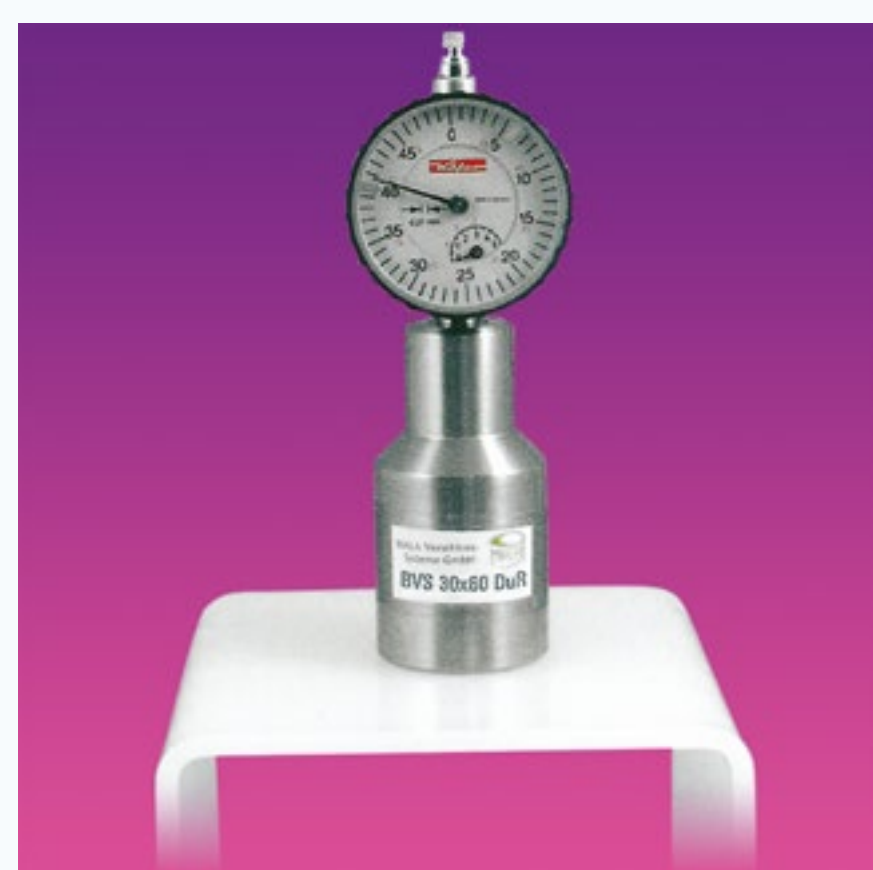
Reform depth gauge

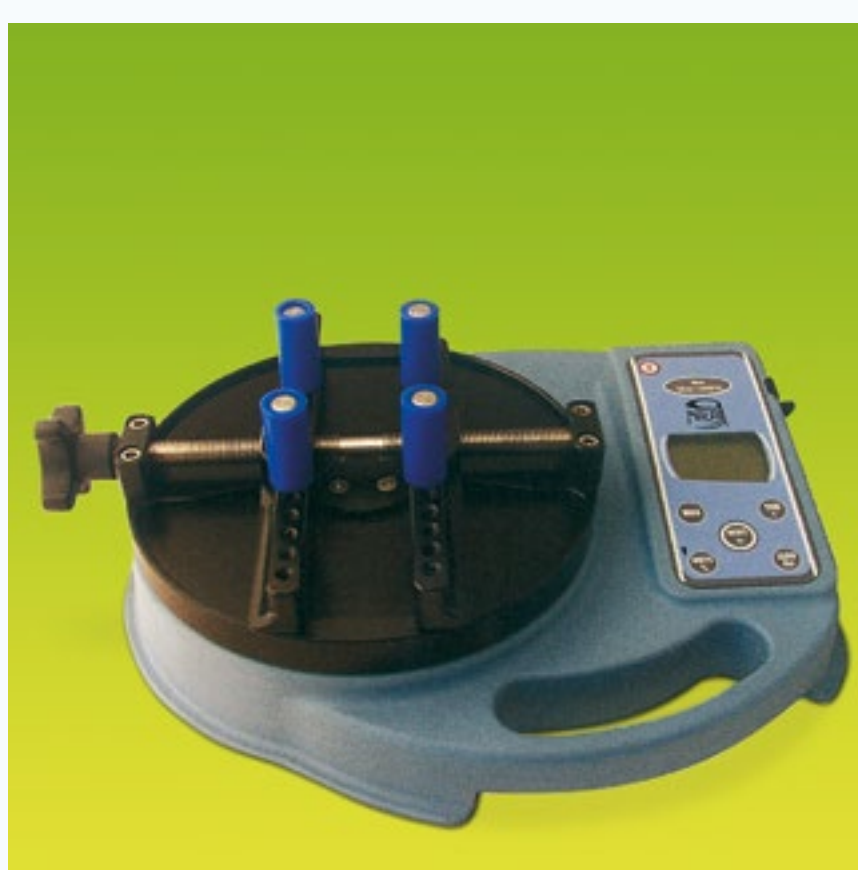
Torque Tester

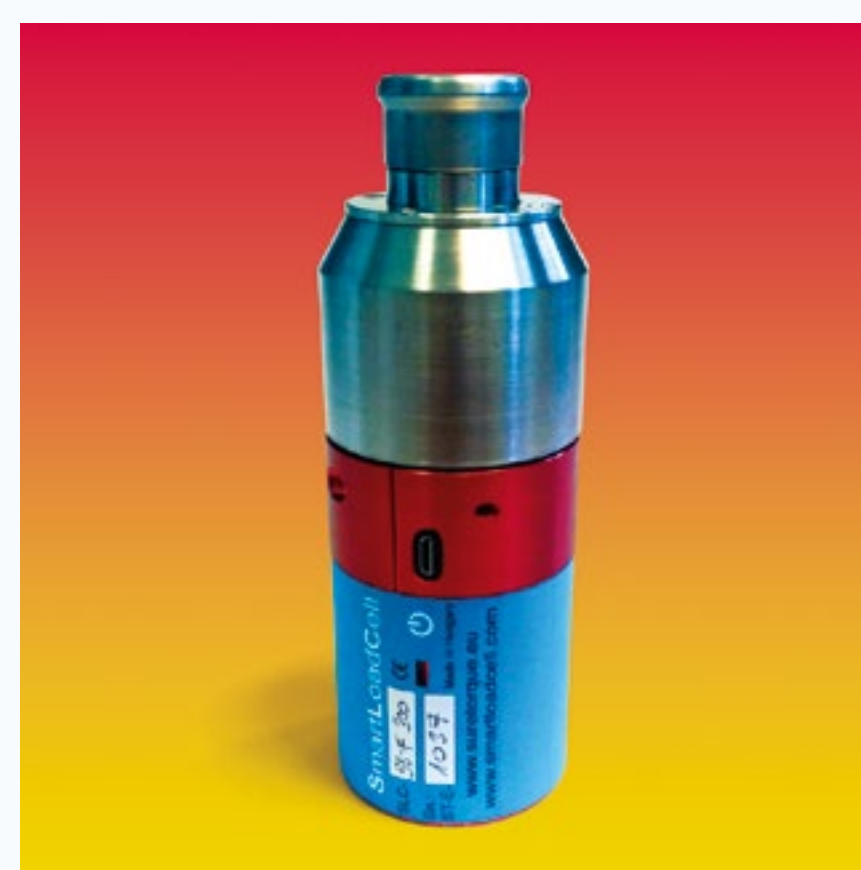
Head Load Gauge
