Sealing technology in practical use:

Perfectly Sealed Closure

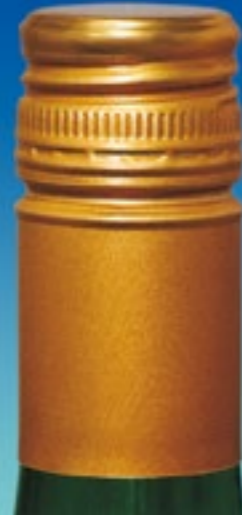
- Symmetrical and well shaped reform
- Damage free thread start
- Correctly formed thread with sufficient forming depth
- Faultless perforation
- Precise and cleanly made tuck-under

- Reliable long-term seal
- Closure opens well with correct pilfer proof function
- Closure will reseal smoothly and safely
